# WASTE ISOLATION PILOT PLANT RECOVERY: A STATUS REPORT

Dana Bryson and José Franco, *US Department of Energy, Carlsbad Field Office, 4021 S. National Parks Highway, Carlsbad, NM, 88220, [dana.bryson@cbfo.doe.gov](mailto:dana.bryson@cbfo.doe.gov)*

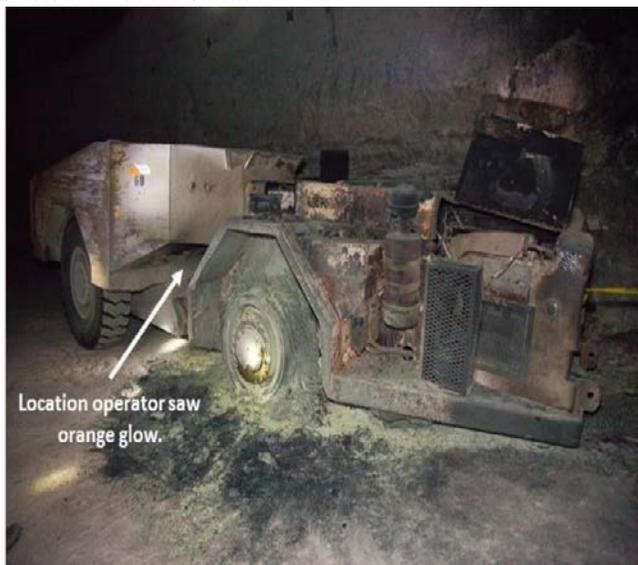
Figure 2. Burnt salt hauling truck in the repository

Figure 2 shows the burnt truck in the repository. The Accident Investigation Board's examination of the truck fire pointed to faulty maintenance as a direct cause, and in evaluating the response to the fire pointed out significant physical and cultural changes that were needed in the facility and in its operations.<sup>1</sup>

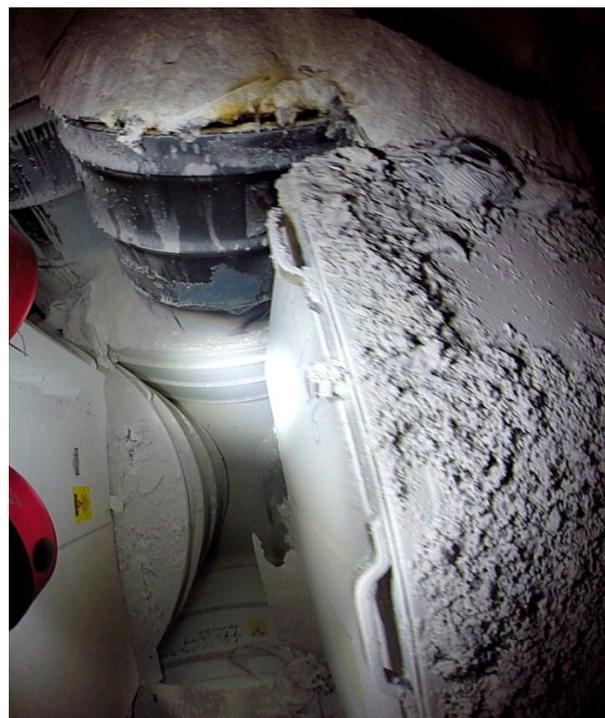
The Accident Investigation Board's cause determination on the release event is ongoing and at this point in time indications are that there was a heat and gas producing oxidation reaction (combustion) in at least one waste container that deformed its lid and ejected some of its contents. A DOE Inspector General's report identified problematic waste treatment practices at the originator site as responsible for the release event while acknowledging that the exact nature of the initiating reaction is not yet known.<sup>4</sup> That release resulted in airborne radioactivity becoming entrained in the underground airflow. Ventilation air flowing underground is continuously monitored for airborne radioactive particulate, and the system worked as intended. The continuous air monitor detected the

Figure 3 shows a view of the compromised drum in the underground. Note that the white granular material on the top of the drum is magnesium oxide, a chemical buffer material placed on top of the waste in large polyethylene bags. During the heating event, bags near the heat source melted and their granular content flowed out and over the edge of the underlying waste containers until reaching its natural angle of repose (see Figure 7). The material on the adjacent waste container (foreground) is suspected to be ejecta from the affected drum in the background.

Figure 3. View of the compromised waste drum in the repository.

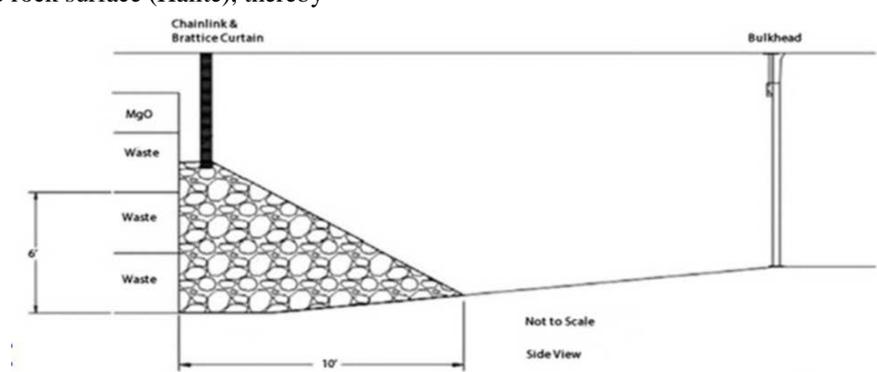
Figure 4. Schematic of chainlink, Brattice cloth, run of mine salt and steel bulkhead preliminary room closure system.

Barriers to be erected to preliminarily seal off the affected room and panel with potentially reactive waste are in the form of a chain-link and Brattice-cloth curtain and run of mine salt, with a steel bulkhead to effectively seal the area from ventilated underground working areas. Figure 4 provides a schematic of this barrier system. Figure 5 shows an example of the proposed steel bulkhead, which is already in common use in the repository. This preliminary closure system will be followed by a permanent closure system once regulatory approvals have been obtained. The preliminary closure system is sufficiently robust to stop aerosol particulate waste discharged into the underground air from a reactive drum.

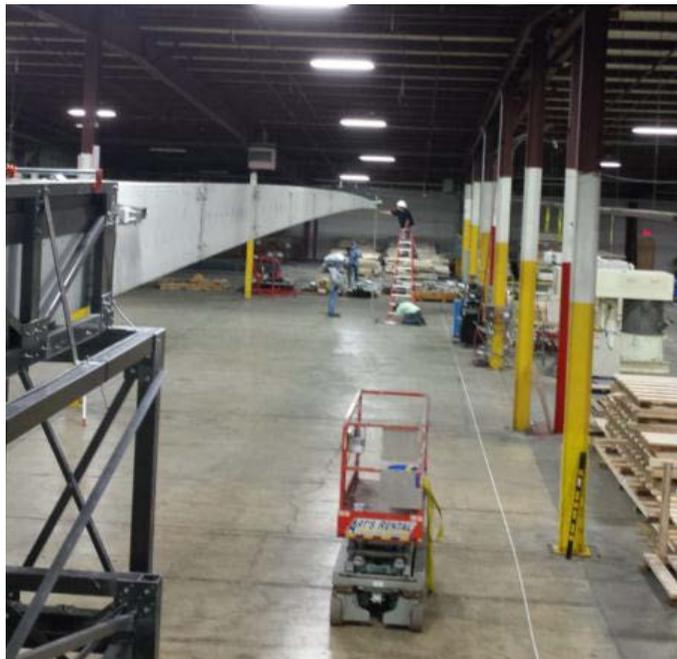
Figure 6. Testing of boom to be used in the underground to examine Room 7 of Panel 7.

The final step in the underground forensics activities being carried out uses a device to individually examine every drum in every waste stack in Panel 7's Room 7. This device, a very long boom of composite material with cameras attached, is shown being tested in Figure 6. This mapping is being done to exclude the possibility of any other cause for the radioactive release.

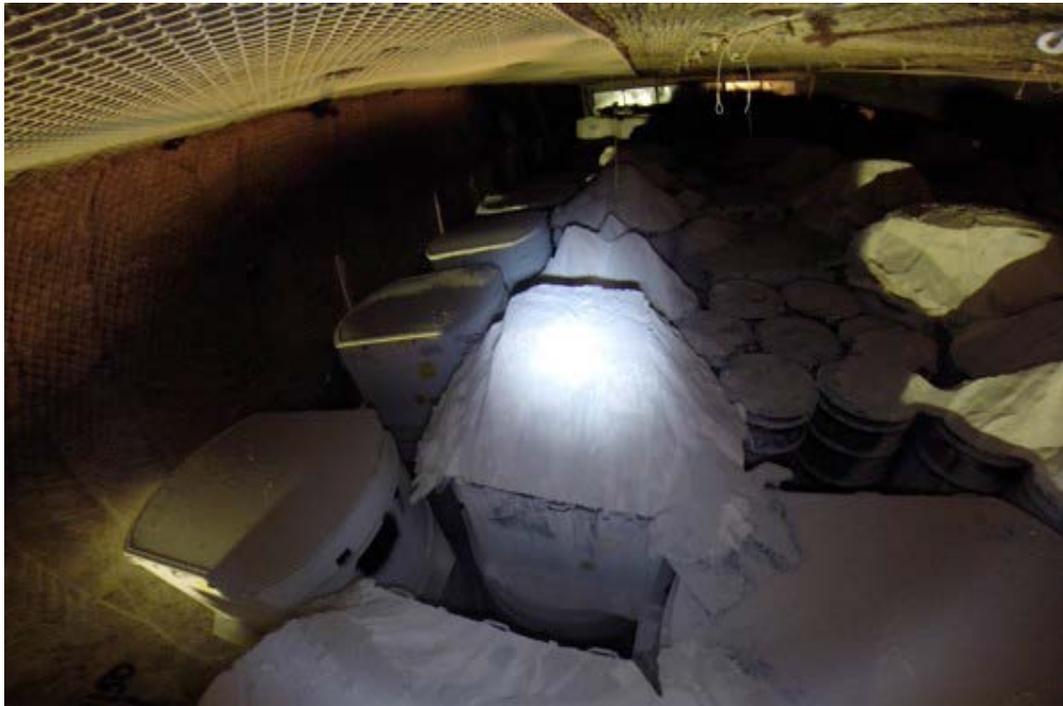
Panel 7 of Room 7 of Panel 7 is shown in Figure 7. Figure 7 indicates the extent to which heat melted the

Figure 7. Room 7 of Panel 7 showing extent of melting of polyethylene magnesium-oxide bags.

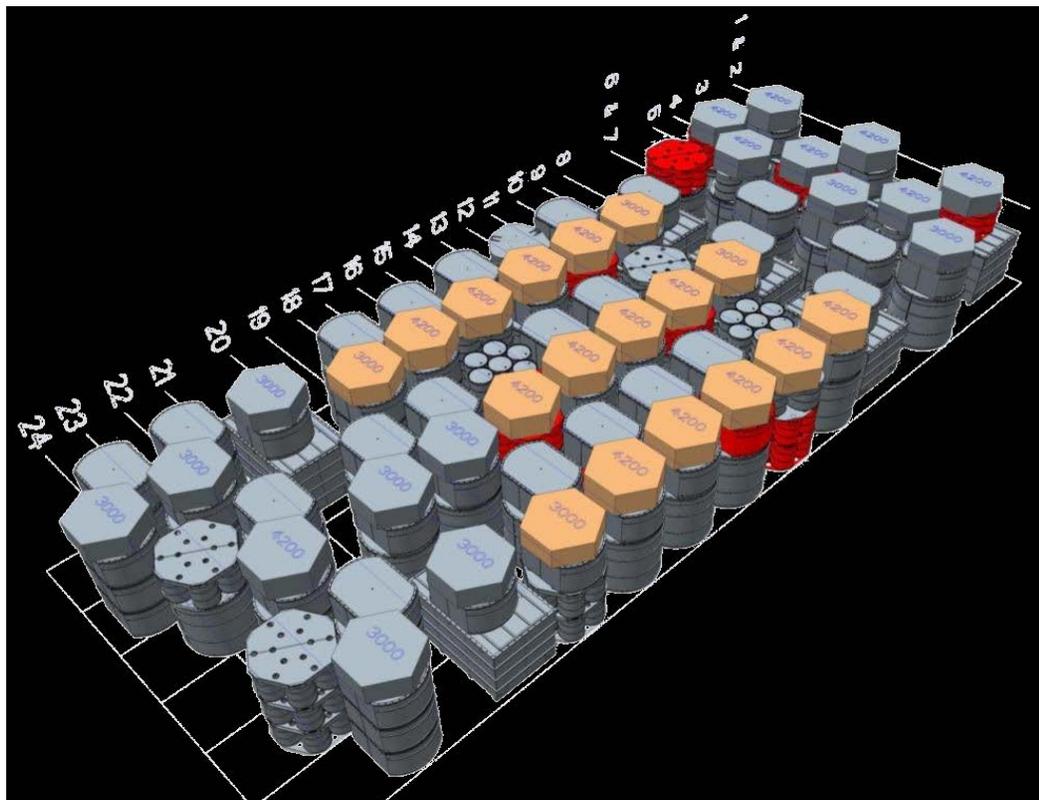
polyethylene bags holding magnesium oxide in this room. Polyethylene melts at 160C, suggesting a very high temperature heat source in the center-right side of the room (see Figure 8). Since the waste is stacked two or three layers of containers high with little space between waste stacks, maneuvering the boom with a camera moving up and down at its end to visually inspect every drum and container in the room, without touching the containers, is a delicate and difficult operation.

Figure 8. Room 7 of panel 7 schematic indicating the location of melted magnesium oxide bags and showing the complexity of using a camera on a boom extended over the waste
