Dry Storage Canister Inspections to Inform Aging Management Efforts

Keith Waldrop

Electric Power Research Institute: 1300 West WT Harris Blvd., Charlotte, NC 28262, kwaldrop@epri.com

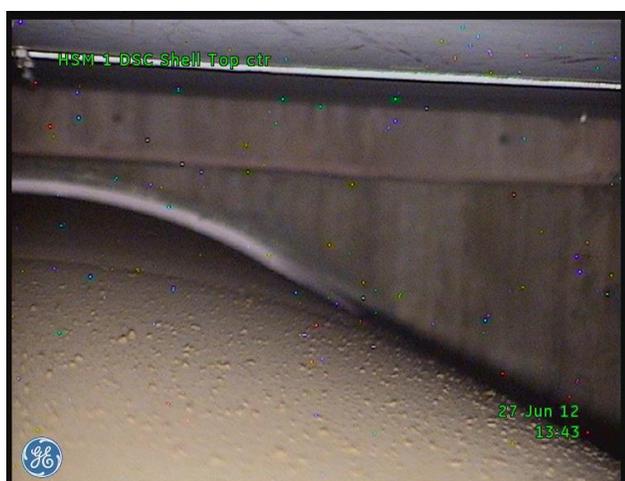
Figure 3. Dust on top of canister at Calvert Cliffs

The visual results showed both canisters had substantial amounts of dust, particularly on the top surface, and a few small rust blooms were observed on DSC-6, however, the general condition of both canisters was good, with no signs of gross degradation. Significant amounts of dust were seen on the upper portions of the

canisters and several small clumps of unknown material were observed (Figure 3). While there was significant dust and material on the top surface of the canister, the lower surface was still shiny and appeared the same as when it was loaded. On both canisters, there was evidence of what appeared to be dripping, possibly from wind driven rain, that left a mark on the canister surface by disturbing the dust in that area. A few areas of rust were observed on DSC-6. Some rust appeared to be associated with what was an initiating scratch that likely occurred during canister loading and transfer, yet other areas were small rust blooms, not clearly associated with any external factors, but may be attributed to free iron contamination during the fabrication process. Some of the painted surfaces on the inside of the storage overpack had some coating failure.

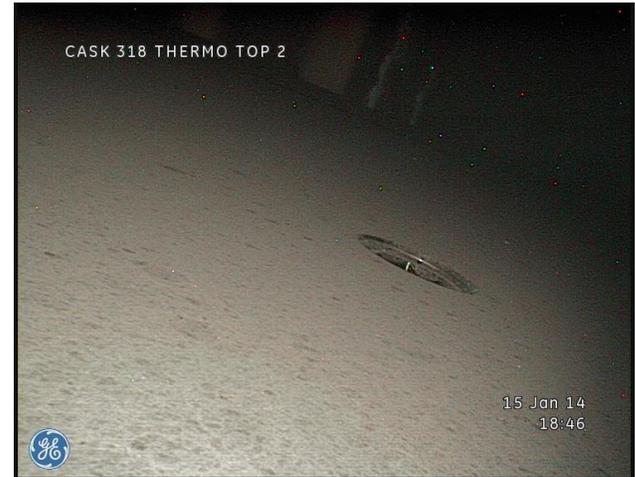
Figure 5. MPC 123 Top Surface and Lifting Hole

For Diablo Canyon, a special quartz fiber scope was used to better withstand the high radiation field instead of the normal scope used at Hope Creek that had some damage from the radiation levels. Again, the borescope provided good visual indication of the tool contact with the canister surface. The canister top lid and closure weld showed no signs degradation. Compared to other inspections, relatively small amounts of dust were observed on the horizontal MPC lid surface (Figure 5). This was likely due to the limited time in service. Some dark spots along the lid were observed and were determined to be small piles of dust. Some spotting on the upper portion of the inner wall surface of the concrete overpack was observed, which tapers off further down the overpack wall. Evidence of some streaking and possible corrosion was seen on the painted carbon steel surface of the inner wall of the concrete overpack. The side surfaces of both canisters showed no signs of degradation and little

to no deposits, which is as expected due to the vertical orientation.
